# 一起 110 kV 电容式电压互感器电磁单元损坏故障分析

李丰, 周冬冬, 倪钱杭, 盛江, 朱涛, 杨嘉炜, 杨智  
(国网绍兴供电公司, 浙江 绍兴 312000)

## Analysis on Fault of Electromagnetic Unit of 110 kV Capacitive Voltage Transformer

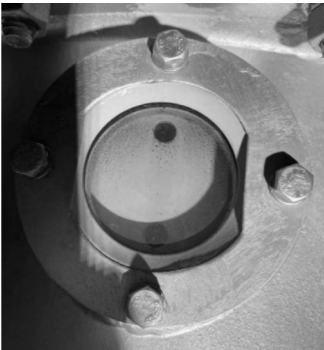
停电后对该 CVT 进行外观检查,本体外观无明显异常,无渗漏油现象,周围无油迹,末屏接地良好。但发现油位过高,观察窗内已无油位线,注油时考虑到热胀冷缩现象的影响,即便此时天气温度较高,油位会适当上升但不会完全没过观察窗,说明电磁单元箱内有异物进入。且观察窗中可以清楚的看到悬浮在其中的黑色微小颗粒,见图 2。

图2 油位观察窗  
Fig. 2 Oil level sight glass

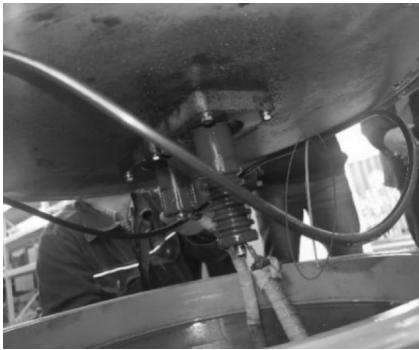
为进一步分析 CVT 具体故障原因,对其进行解体检查。将电容单元与电磁单元法兰连接螺栓拧下后,发现在二者连接的密封圈处存在一根不应该存在的尼龙扎带,密封圈与扎带接触处有明显的压损痕迹,且电容单元底板处存在有明显的锈迹;电容单元与电磁单元连接线完好,具体见图 3。

图3 密封圈处存在尼龙扎带  
Fig. 3 Nylon tape at the sealing ring

综合上述试验及解体检查结果,判断该 CVT 电容单元并无故障,分析认为这是一起由于水分进入电磁单元导致绝缘受潮而发生的放电事故。CVT 生产过程中在电容单元与电磁单元密封圈处不慎混入了尼龙扎带,扎带的存在使得法兰连接处密封不严,并且扎带高高翘起,与箱壁间存在一定的角度,角度的存在使得水分从扎带与密封圈相接处进入电磁单元并顺着扎带流进元器件内部,而不是顺着箱壁进入油中后因为密度较大的原因沉入到箱底,水分进入路径见图7。

- 1)应加强整机组装后的试验或异物检测等技术手段;
- 2)运维人员对 CVT 要加强监视,特别是电磁单元油位和二次电压要密切关注,一旦发现油位过高或二次电压有明显异常应及时上报;
- 3)加强停电检修时对 CVT 的电气试验和油色谱试验检测。

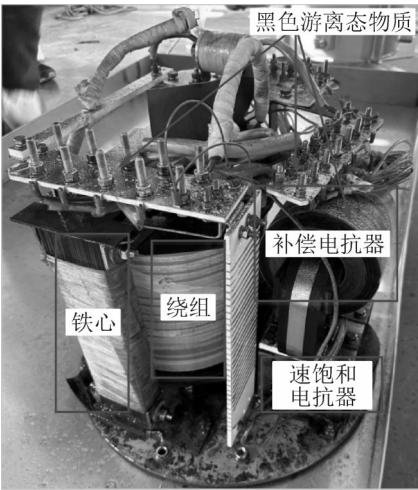
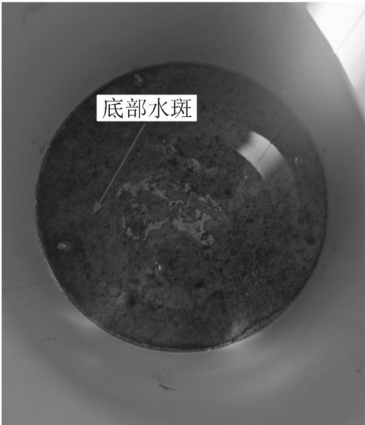
将电磁单元从箱内取出后发现电磁单元外部元器件如接线板、补偿电抗器外表面布满了黑色游离态物质,绝缘油已变色,箱体底部可见明显的大片水斑,见图 4。由此初步推测应该是电磁单元箱

密封不严,水分进入导致 CVT 故障,故障产生的黑色游离态物质在绝缘油中四处游走,附着在各元器件表面。

图4 黑色游离态物质及底部水斑  
Fig. 4 Black free material and bottom water spots

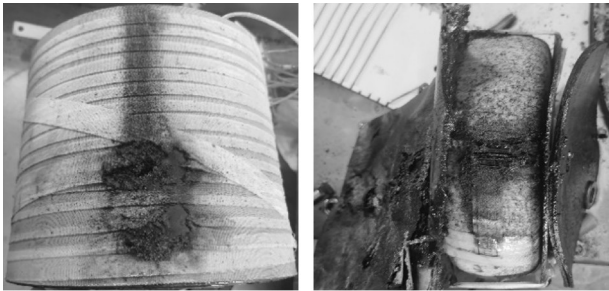
将电磁单元拆解后发现阻尼电阻和补偿电抗器完好,铁心端面有发热氧化痕迹,中间变压器一次绕组及其附近的速饱和电抗器存在明显的放电击穿现象,放电能量将两者的外层绝缘以及两者间的绝缘纸板彻底击穿,同时伴随有黑色颗粒状物质产生,见图 5。

图5 一次绕组及速饱和电抗器击穿部位  
Fig. 5 Breakdown position of primary winding and fast saturation reactor

水分的存在使得一次绕组中的绝缘纸、漆包线受潮,因而绝缘强度大幅度下降,线圈层与层、匝与匝之间因绝缘强度不足而发生放电<sup>[25-27]</sup>,放电产生的能量将线圈与绝缘纸击穿,同时激磁电流增大,铁心饱和发热,二次失压。水分的存在也降低了一

次绕组与速饱和电抗器间绝缘板的绝缘强度<sup>[28-29]</sup>,速饱和电抗器电位较低,高电位的一次绕组向速饱和电抗器放电,速饱和电抗器绝缘被击穿。

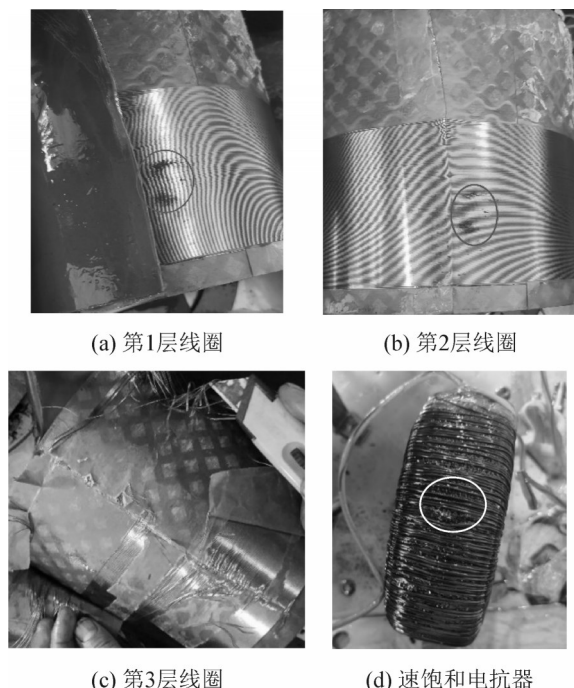
圈处发现明显的击穿点。第一层线圈黑色击穿点较为明显,第二层线圈则明显黯淡了许多,第三层线圈处已无明显可见的击穿点,说明放电主要发生在一次线圈的外侧。将速饱和电抗器绝缘剥开后,发现速饱和线圈同样存在放电烧蚀痕迹,但放电痕迹并不是特别明显,见图6。拆解时发现绕组与饱和电抗器间的绝缘纸板已明显分层,绝缘纸板和高压绕组绝缘层中含有大量水分。

图6 一次绕组及速饱和电抗器击穿点  
Fig. 6 Breakdown point of fast saturation reactor and primary winding

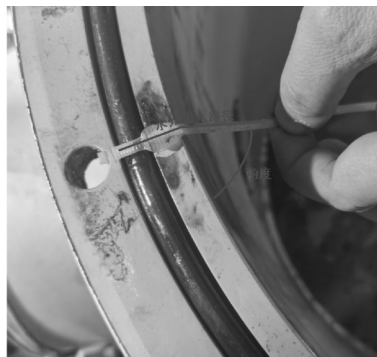
图7 水分进入路径  
Fig. 7 Moisture penetration path

综上所述,这是一起由于厂家质量把关不严,产品中混入不该存在的扎带,造成电磁单元密封不严、水分进入,导致绝缘受潮后绝缘强度降低而发生的一次线圈层间、匝间以及与低电位设备速饱和电抗器间的放电事故。
